MAP SHOWING RECENT AND HISTORIC LANDSLIDE ACTIVITY ON COASTAL BLUFFS OF PUGET SOUND BETWEEN SHILSHOLE BAY AND EVERETT, WASHINGTON

Rex L. Baum, 1 Edwin L. Harp, 1 and William A. Hultman 2

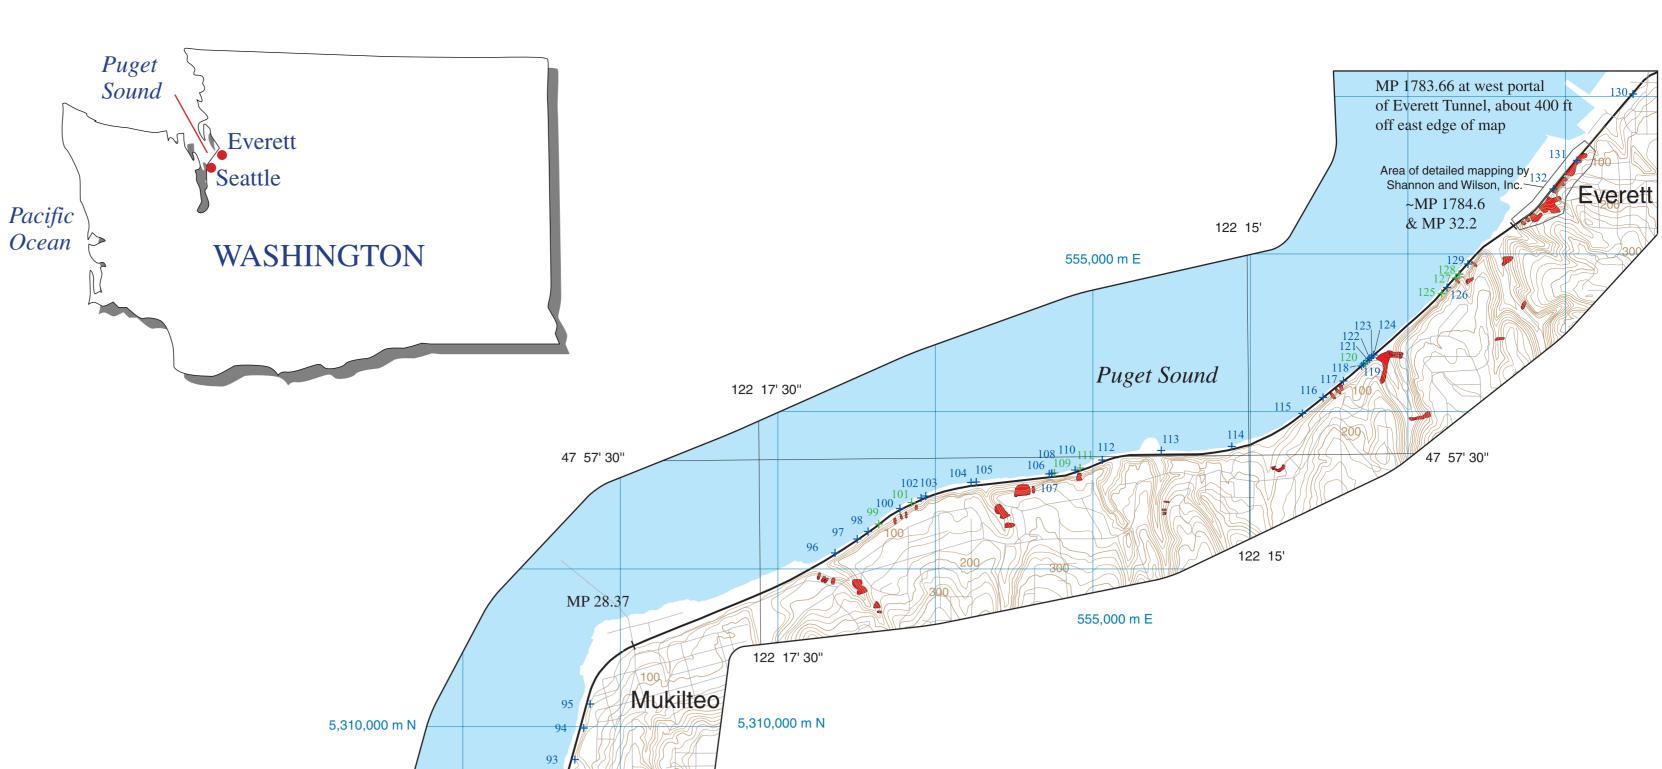
Area of detailed mapping by Shannon and Wilson, Inc. Puget Sound 550,000 m E Figure 2 122 20' Figure 2. Landslides south of Mukilteo, Snohomish County, Wash. These slides severely damaged the lawns behind two homes,

stripped vegetation from the steep slopes above the railroad, and deposited material on the tracks. Movement near the top of the slope is predominantly translational and the extension fractures in the lawn are consistent with retrogressive failure from the edge of the steep slope.

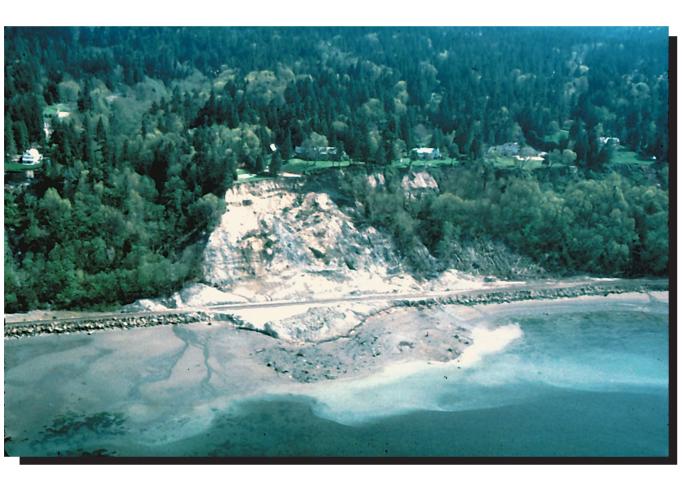
Figure 3. The January 15, 1997, Woodway landslide, Snohomish County, Wash. This complex landslide began as a deep-seated, rotational slide. Much of the slide mobilized into a debris flow that derailed several cars of a passing freight train. Shallow earth slides and debris flows also occurred on the slope directly south (to the right) of the rotational slide.
