9 February, 06:00:41.6. Mag. 6.4. Main shock of the San Fernando earthquake. Epicenter  $34^{\circ}24.7'N.$ ,  $118^{\circ}24.0'W.$ , southern California, at a depth of about 8 km., P. This location is about 14 km. north of San Fernando in a sparsely populated area of the San Gabriel Mountains. No foreshocks were recorded. Numerous strong aftershocks were recorded. One hundred seventy-four aftershocks of magnitude 3.0 or greater were recorded up to 23:36:06.5 on February 9, with two of magnitude 5.8 occurring at 06:01:08.0 and 06:02:44.0. Thirty-one clear aftershocks were recorded on the Pacoima Dam strong-motion accelerograph, located about 8 km. south of the epicenter, from 06:01:08.0 to 06:05:58.0. The main shock record from the Pacoima Dam accelerograph showed the highest accelerations ever measured, 1.25 g. horizontally and 0.72 g. vertically. A very large number of aftershocks were felt, keeping people in a state of apprehension for weeks. An observer at Burbank reported over 120 aftershocks were felt up to June 21.

Figure 2. Epicentral area of the San Fernando, California, earthquake of February 9, 1971.

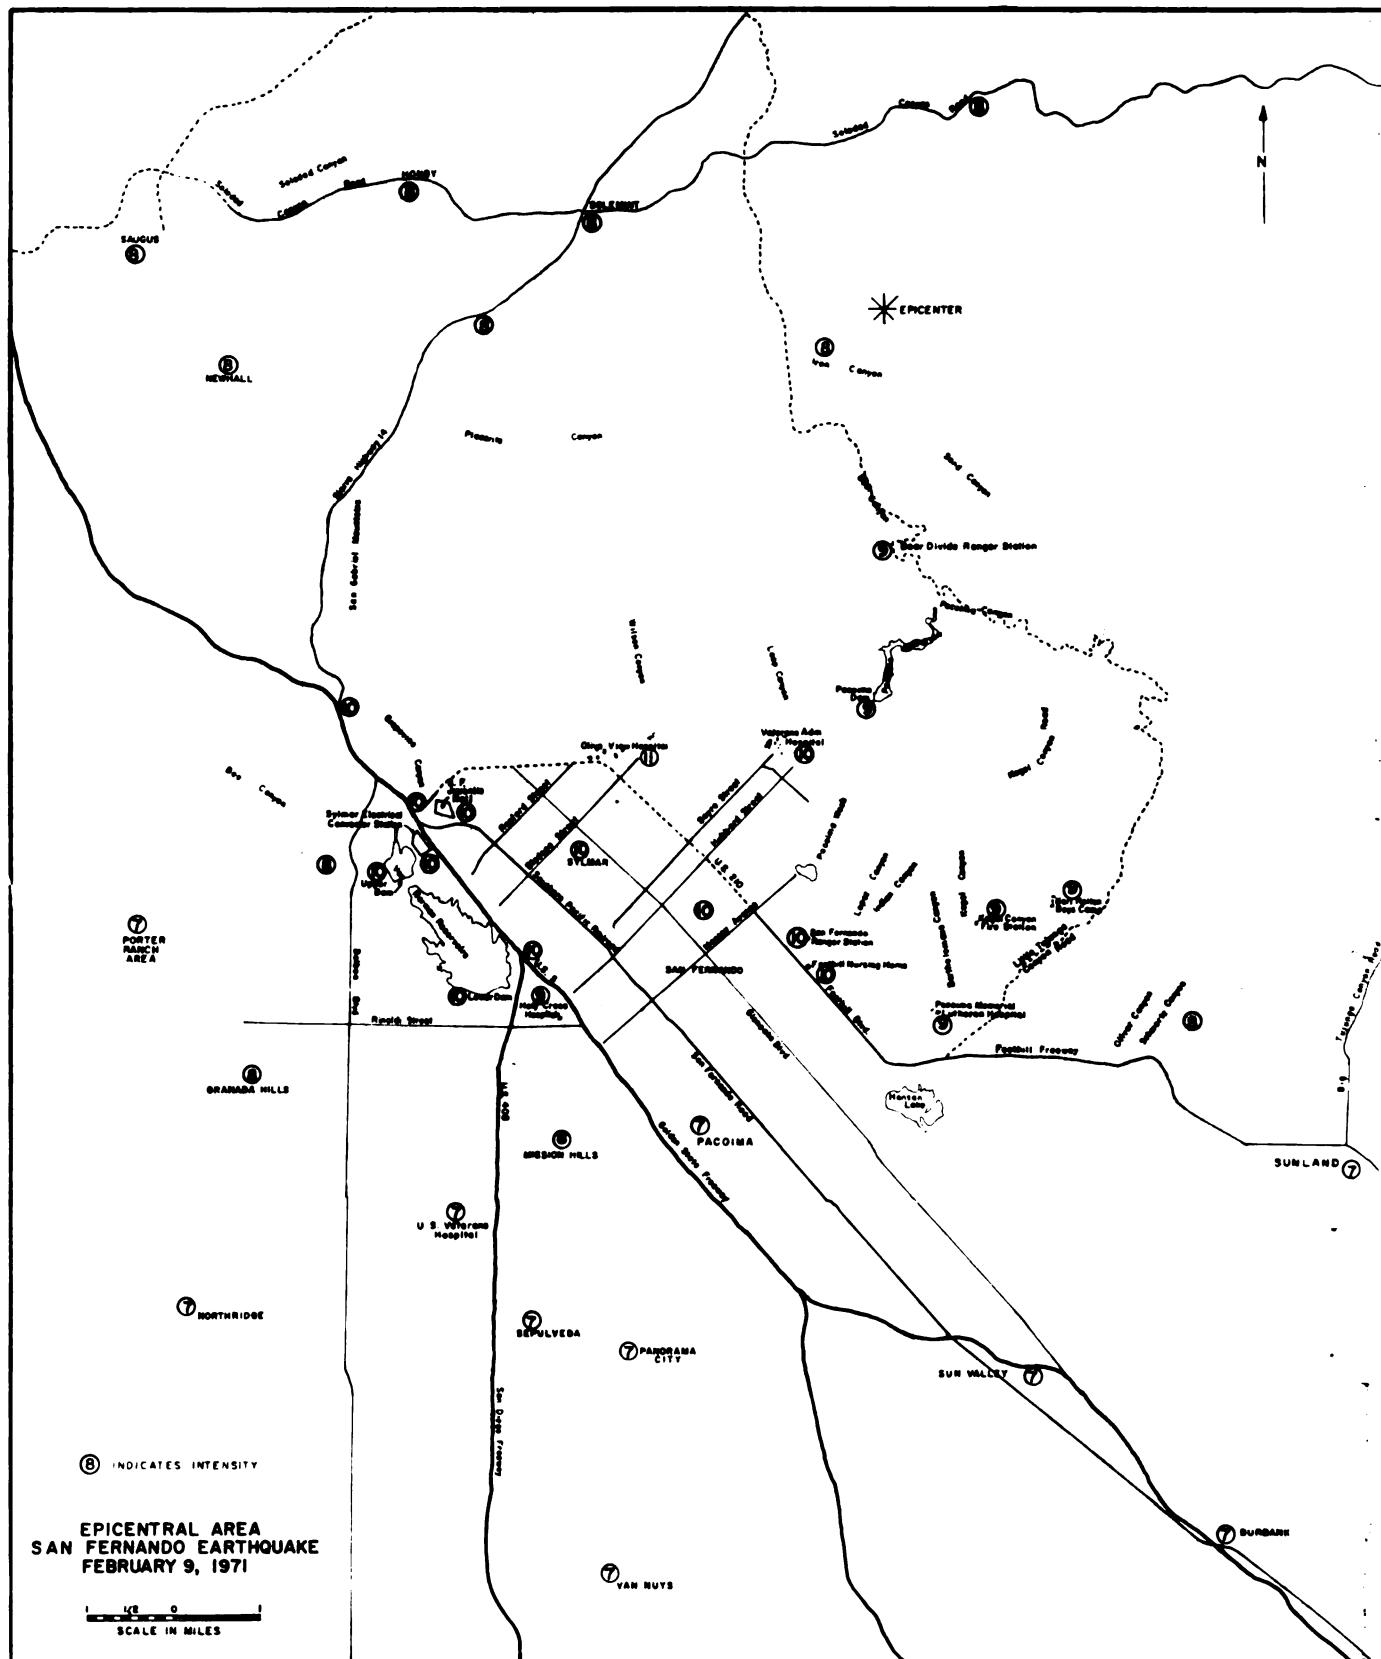
Intensities ranging from VIII to XI (fig. 2) were indicated in an area of about 490 sq. km. (190 sq. mi.), with the one int. XI assigned to the Olive View Hospital complex. This facility, completed only a few months prior to the earthquake at a cost of approximately \$23.5 million, was declared a total loss. Intensities ranging from IX to X were generally indicated in the San Fernando-Sylmar area and adjacent areas, and were based on ground ruptures, damage to buildings, dwellings, highway structures, dams, underground pipelines, and other utility facilities. Considerable damage, mainly to older buildings and dwellings, occurred in the int. VII zone. Some were posted as "unsafe" and others, notably in the Alhambra, Beverly Hills, Burbank, and Glendale areas, were to be demolished. A few large buildings sustained some structural damage, but damage to large or high-rise buildings was chiefly in the form of cracked partitions, fallen plaster, and broken windows. Thousands of chimneys were damaged. There were numerous reports of inoperative elevators, principally owing to counterweights being out of guiderails.
