Map of Debris-Flow Features Evident after the Storms of December 1955 and January 1982 in the Montara Mountain Area, California

MAPS OF DEBRIS FLOW FEATURES EVIDENT AFTER THE STORMS OF DECEMBER 1955 AND JANUARY 1982, MONTARA MOUNTAIN AREA, CALIFORNIA

by
Carl M. Wentworth

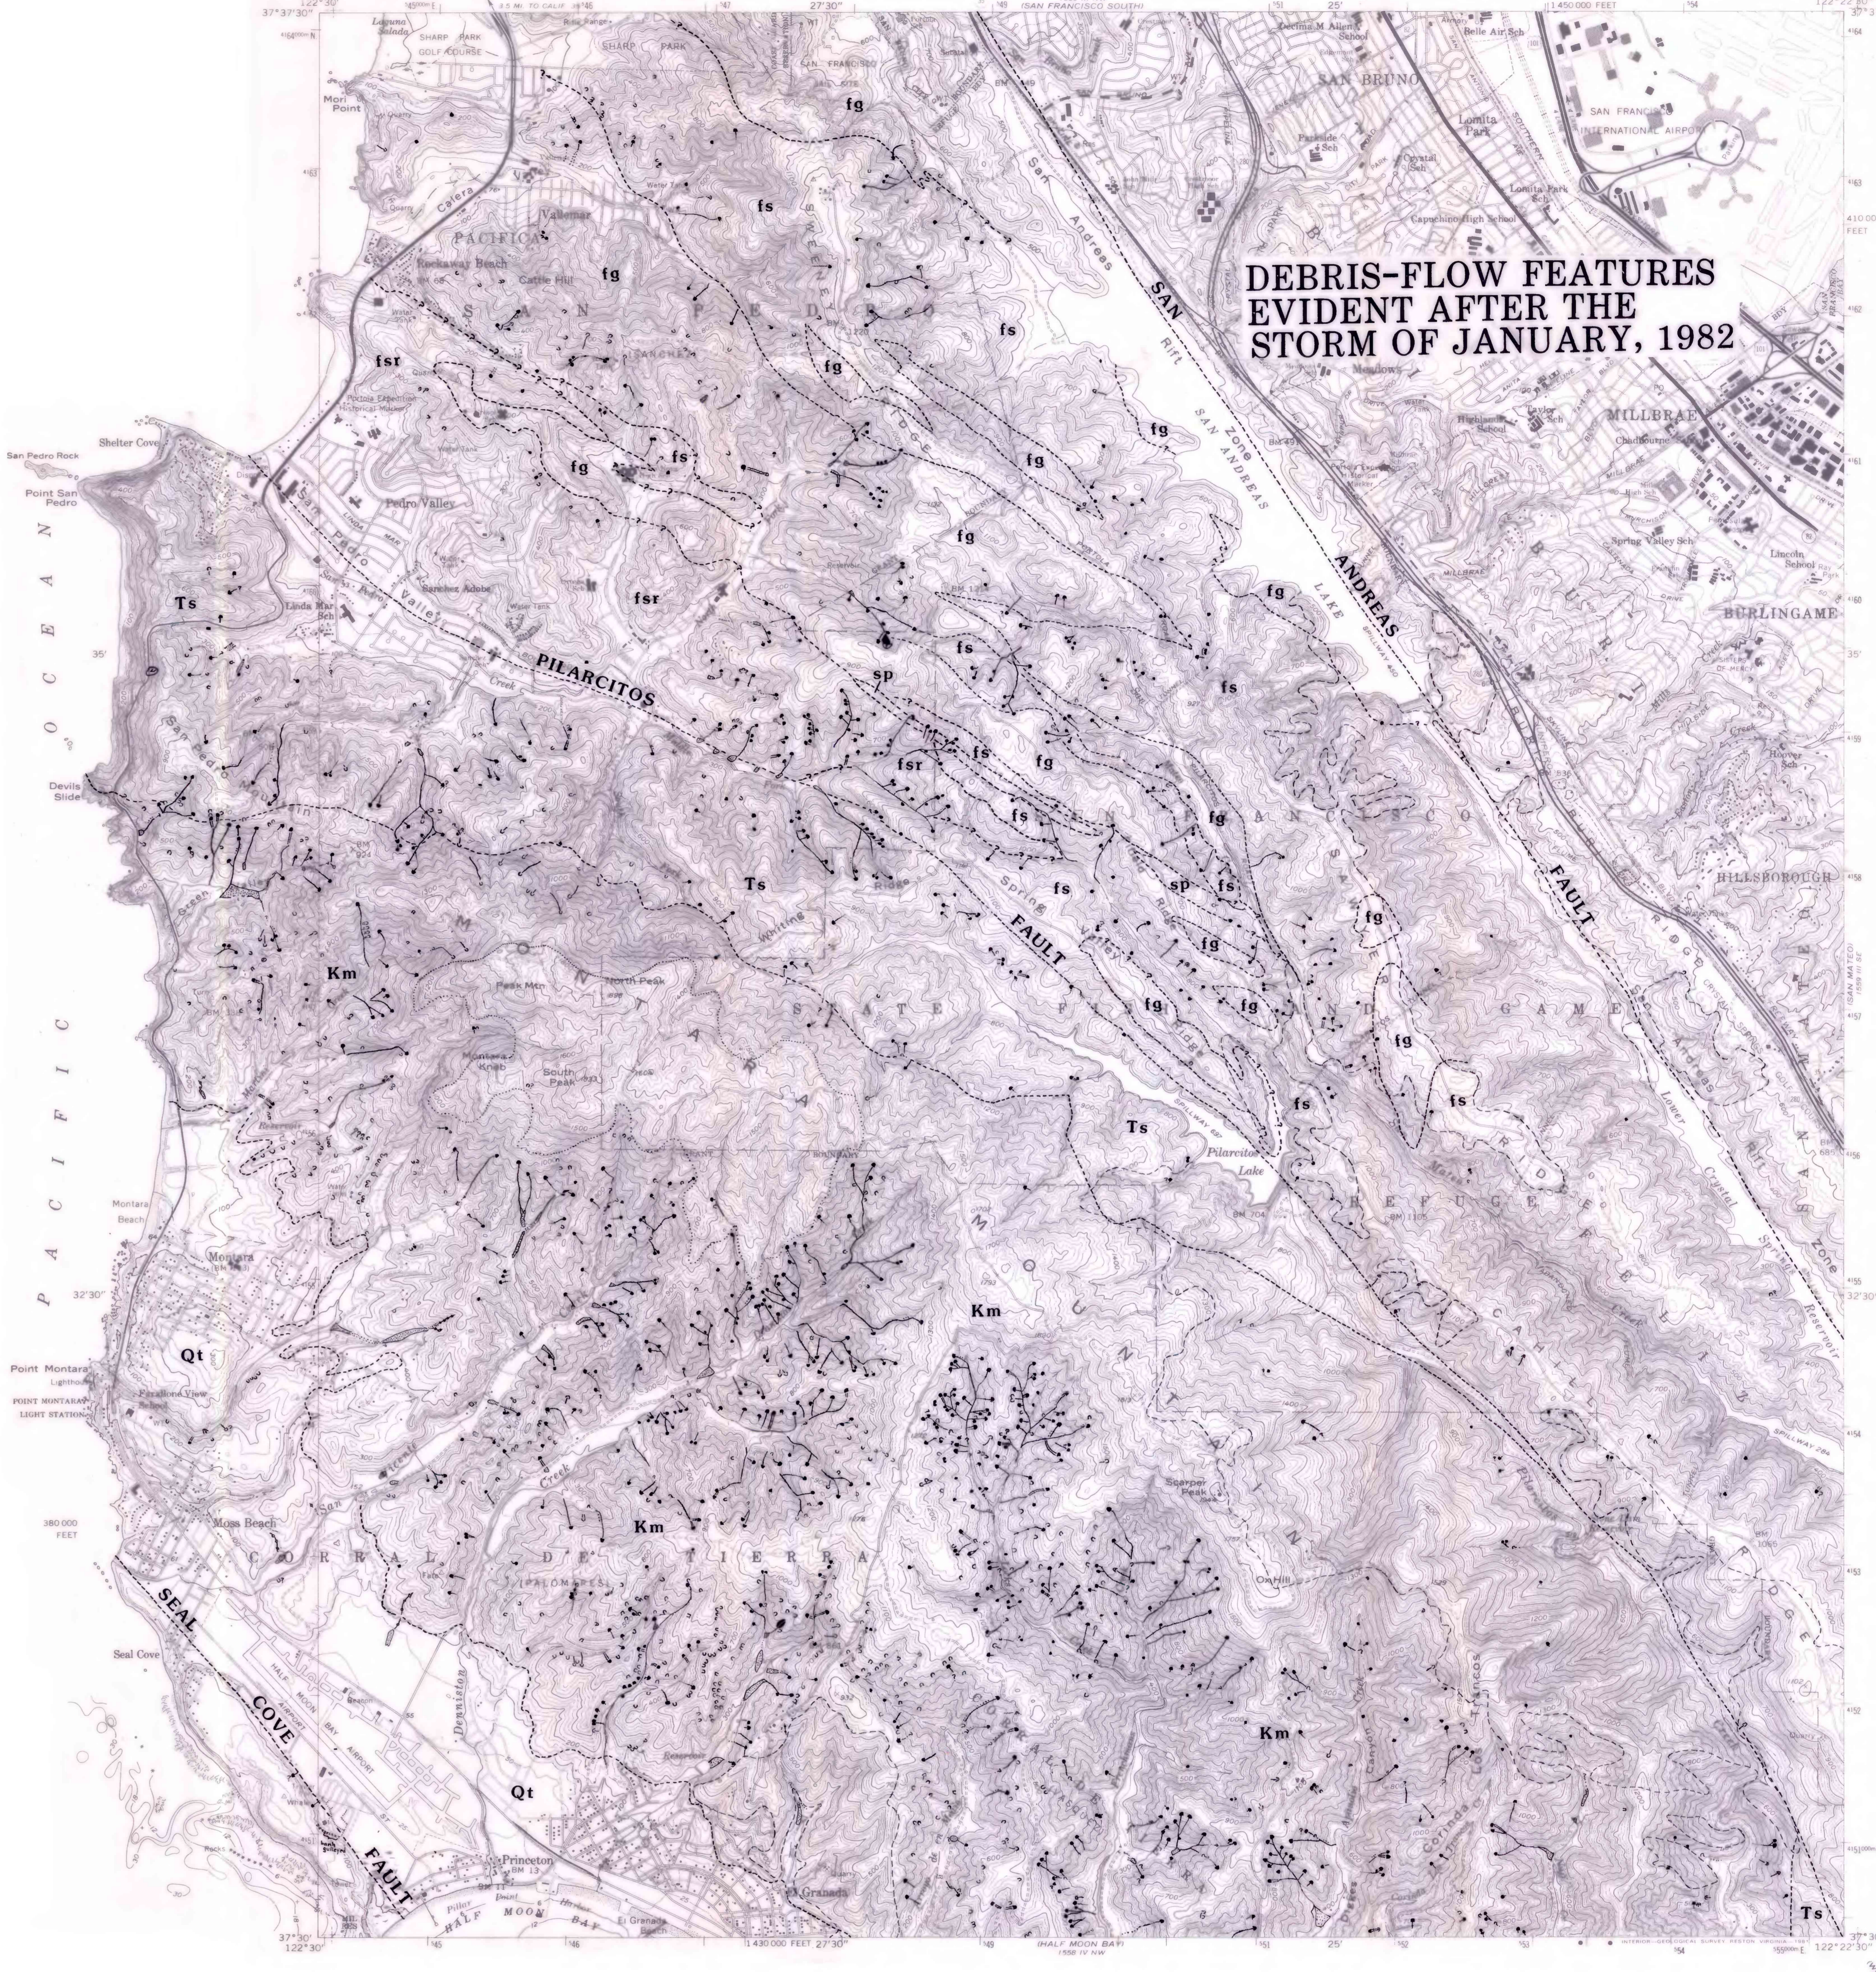
This map inventory shows soil-slip debris flow produced during the 1955 and 1982 storms and in the remainder of each rainy season, together with those debris-flow features formed in the years prior to each storm that were still evident in the landscape. The inventory serves two main purposes. It stands as a record of the occurrence of debris flows in the map area, particularly during those two triggering storms. This will aid evaluation of future hazard from debris flows in the map area. It also provides data on debris flow occurrence and behavior for use in the continuing effort to better understand debris flows in the region; steep, brush-covered slopes mantled with coarse granular soil derived from the underlying fractured granitic rock. Mapping was done principally by interpretation of aerial photographs, supported by limited field study to aid photo identification of soil-slip and debris-flow features.

The debris flows -- soil-slip scars, debris-flow tracks, and new deposits -- were mapped by stereoscopic study of aerial photographs. The photo observations were calibrated and locally supplemented by field study in the map area and elsewhere in the region after the January storm in 1982. Plotting on the base map was done visually, using symbols that, because of the scale, necessarily exaggerate the size of most of the features (except track lengths).

Debris flows were identified by a characteristic signature, which in its fresh, complete form consists of (1) a bare, sharply bounded scar on a steep slope that marks the site of initial failure of a slab of surficial mantle as a soil slip, (2) a narrow downslope track, light colored and generally bare of vegetation, which marks the path of the liquefied mass of surficial mantle where it flowed straight downhill from the scar and then on down subsequent stream courses, and finally (3) a thin, light-colored sheet of sediment newly deposited where the flow debouched onto a gently sloping alluvial surface. In many cases only part of this complete debris flow was evident. Recognizable old soil-slip scars and debris-flow tracks were mapped as well. Most tracks in
